MeltFlipper® Case Study

Nypro

Case Study: Eliminating Material Degradation through MeltFlipper® Technology

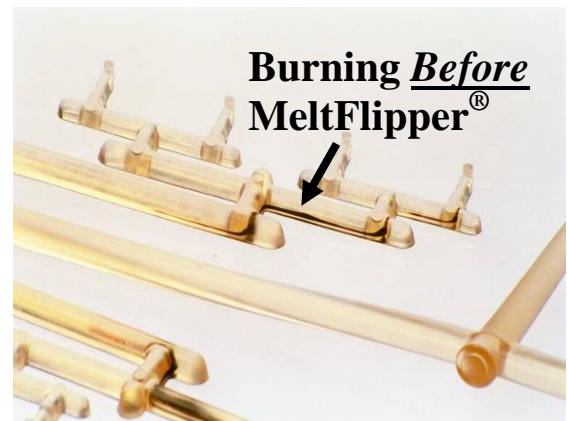
Figure 2: Illustration showing material degradation due to shear burning in a 32-cavity flexible PVC mold.

The molder also tried adding radii on the corners to eliminate those areas as the cause of the shear burning, but this did not solve the problem since shear is developed throughout the entire runner system - not at a corner in the runner system. The molder also made an attempt to add cold slug wells in the runner to eliminate the burning. However, this also did not improve the situation. Because the cold slug wells are filled instantaneously, and because of plastic's laminar flow, the same high-sheared material followed behind the material in the wells. As it can be seen in Figure 2, the degraded material flowed directly around the cold slug wells and into the part cavities.

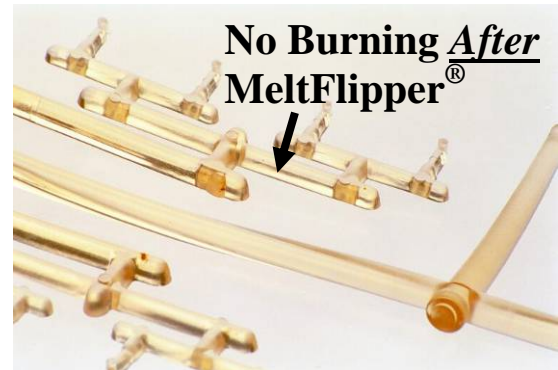
Figure 3: Illustration showing how the MeltFlipper technology eliminated the material degradation due to shear burning in a 32-cavity flexible PVC mold.

Adding MeltFlipper technologies into strategic positions within the runner system controlled and managed the melt down the runner and distributed the high shear across all cavities. By dividing the shear between the various runner branches, the long continuous development of heat is minimized, thereby eliminating the burning on the inside cavities (Figure 3).

The MeltFlipper runner insert also improved material uniformity, so there was no longer flashing on the inside cavities or short-shots on the outside cavities. Resolution of these issues allowed the molder to reduce clamp tonnage by 50 tons, run the tool in a less expensive press, and reduce injection pressure by 300 psi - all while running 32 cavities within specification.
